EVALUATION OF DAMAGE OF ALL-WELDED LONGITUDINAL MAIN BEAMS OF THE E.O. PATON BRIDGE ACROSS THE DNIPRO RIVER

V.D. Poznyakov, V.P. Dyadin, Ye.O. Davydov and R.I. Dmytrienko

E.O. Paton Electric Welding Institute of the NAS of Ukraine

The problem of general evaluation of technical condition of main longitudinal beams of the E.O. Paton Bridge was considered based on the results of selective non-destructive testing of truss elements. It is shown that the main cause of damage to the elements of the main beams is corrosion of the nodal welded joints in the places of debris accumulation. High quality of welded butt joints made by automatic and semi-automatic submerged arc welding was noted. 10 Ref., 18 Figures.

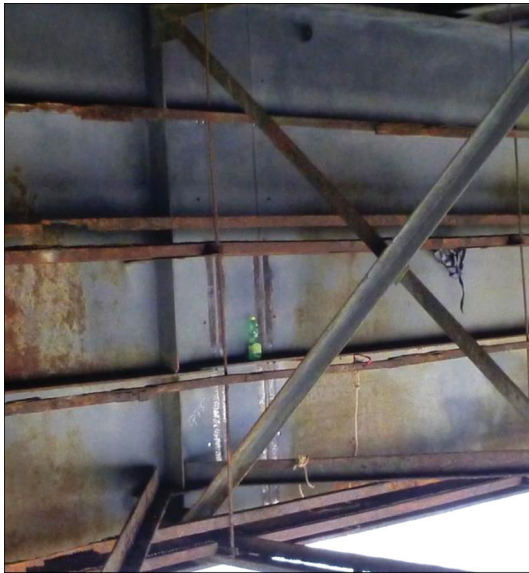
Figure 5. Example of testing butt vertical welds of the joining insert

The main attention during the selective ultrasonic testing of butt welds was paid to the places where defects were detected during the erection and manufacture of truss elements [3, 4, 9], and to the maximum stressed areas. At a total length of erection and shop welded joints of about 110 km, 150 m of welded joints were inspected, 50 % of which amounted to erection welds at the places of joining trusses (Figures 2, 3, 5, 6).

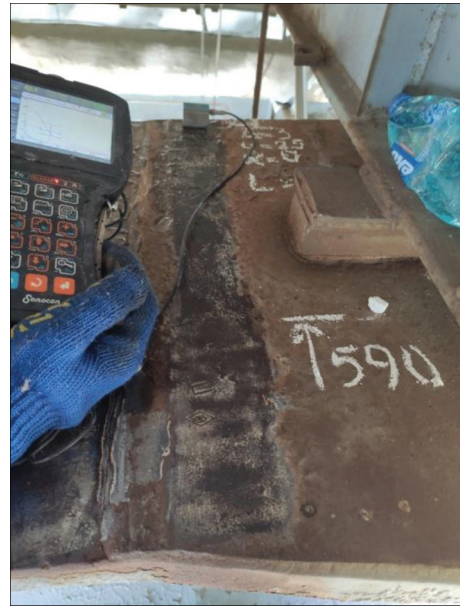
Figure 6. Example of testing butt weld in the upper girth of the joining insert

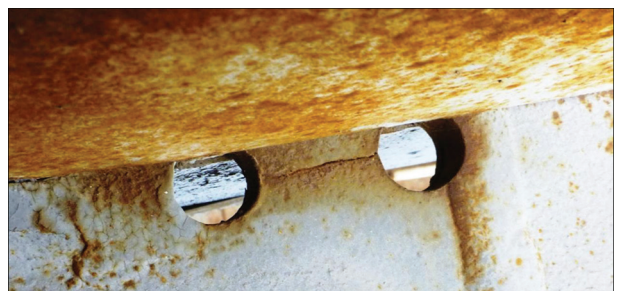
defects that were detected already at the stage of construction of the bridge, did not propagate in the process of a long-term operation (Figure 7).

Figure 7. Example of absence of growth of a defect left during erection (ends of the crack were arrested by drilling method) [4]

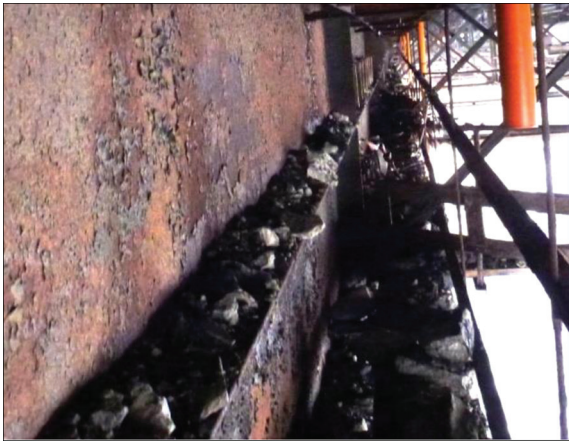
Figure 8. Area of debris accumulation and condition of inspection passages on the inner side of the end beam of the five-span structure

of thickness from corrosion. This was especially observed in the areas of large debris accumulation on the lower horizontal stiffeners, the lower girths of the end beams and at the ends of the supports of the span structures (Figures 8–10).

The greatest loss of metal thickness as a result of corrosion was found in the trusses of the end main beams No.1 and No.4 (Figures 14, 15). The main cause for such a damage was the presence of debris on the lower horizontal stiffener and the lower girth of these beams, which retains moisture (Figures 8–13).

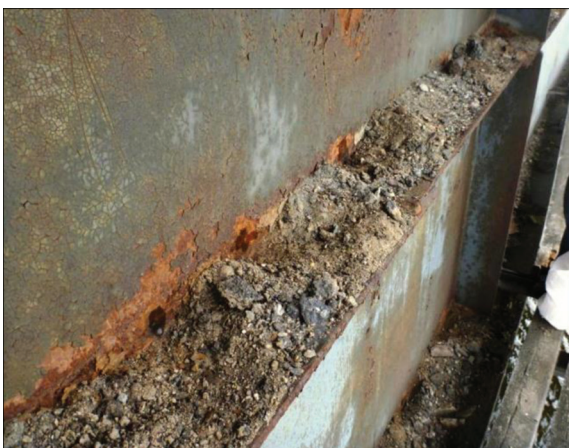
Figure 9. Area of debris accumulation on the outer side of the end beam of the five-span structure

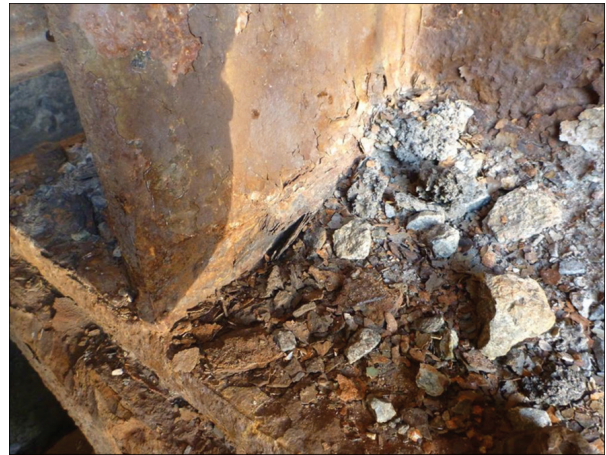
Figure 10. Area of debris accumulation in the supporting part of the four-span structure

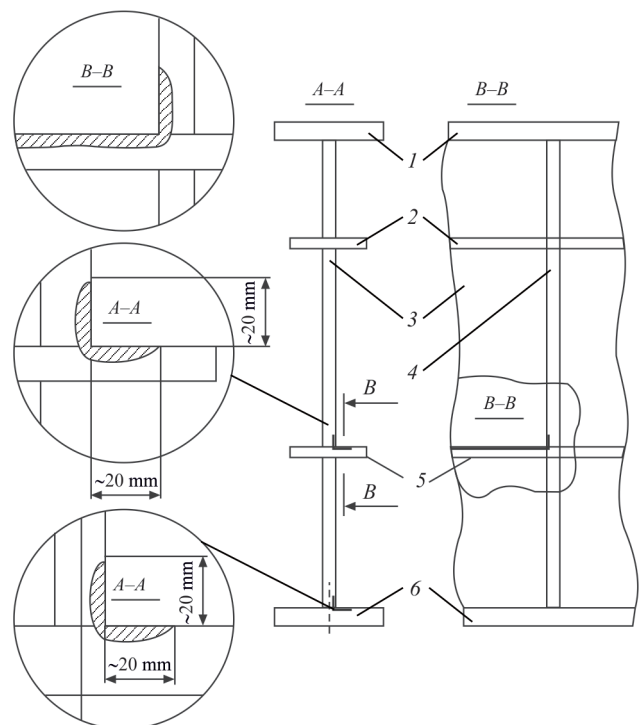
Figure 11. Typical corrosion damages of welded joints of truss elements of the main beams: 1 — upper flange; 2 — upper horizontal stiffener; 3 — wall; 4 — vertical stiffener; 5 — lower horizontal stiffener; 6 — lower flange

was carried out and on the generalized schemes of span structures. The most typical places of corrosion damages of welded assemblies of the main beams of the bridge are presented in Figure 11.

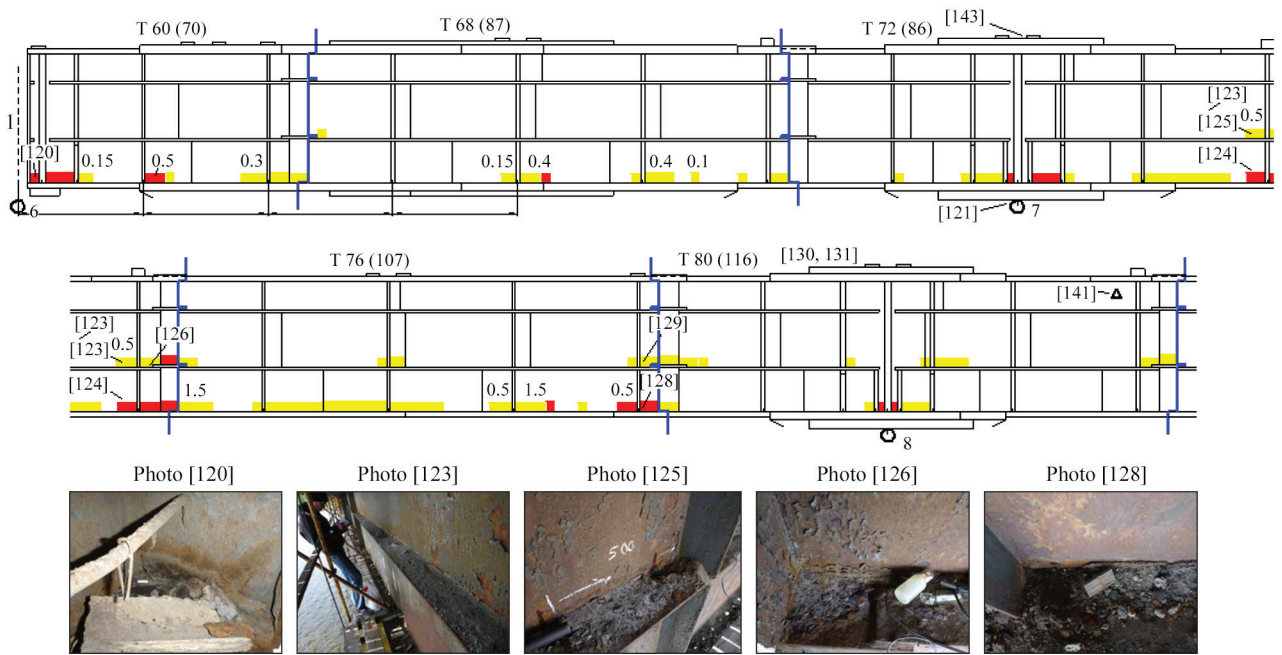
Figure 12. Fragment of tabulated results of testing elements of the beam No.1 of the five-span structure located between the 6-9 support

As an example, Figures 12, 13 present the sections with detected corrosion damages and a delamination of the main beams of span structures.

loss of metal from corrosion is in the range from 2 to 4 mm are yellow and red where it is more than 4 mm. A number above the color indicates the approximate length of the corresponding area along the truss. A separate square of yellow or red colour corresponds to a length of about 100 mm. If the area is separated by structural elements, such as for example vertical stiffeners or welded sheet joints, then a number above the color is not marked. Nonmetallic inclusions are green. The boundaries of trusses are marked in blue. Movable and immovable supports are respectively — \circ 22 \triangle 23. In square brackets, the numbers of photos of some sections are given. The sections that were not subjected to a selective testing are marked with dotted intersection. Defects are marked in black according to the data of LLC «V.N. Shimanovsky Ukrainian Institute of Steel Construction», given in the report compiled based on the results of the inspection of the bridge in 2018.

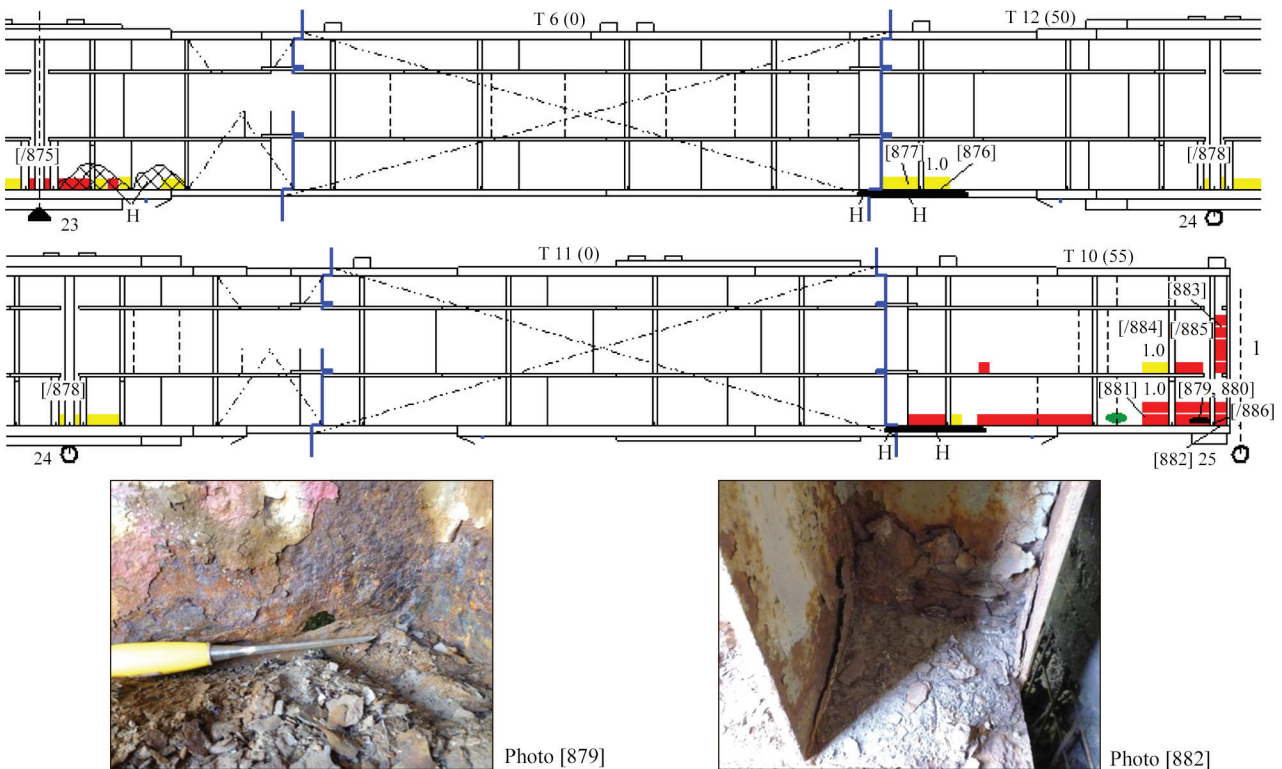
Figure 13. Fragment of tabulated results of testing elements of the beam No.1 of the four-span structure located between the 21–25 support

The maximum corrosion damages to the elements were detected in trusses T10 and T15 of the four-span structure of the main beam No.1 and trusses T1 and T3 of the four-span structure of the main beam No.4. In these trusses deep corrosion damages (rust-through in some places, Figure 13), which need urgent repair.

5. The deepest corrosion damages (in some places through) were observed in the trusses T10 and T15 of the main beam No.1 and the trusses T1 and T3 of the main beam No.4. These trusses need urgent repairs.

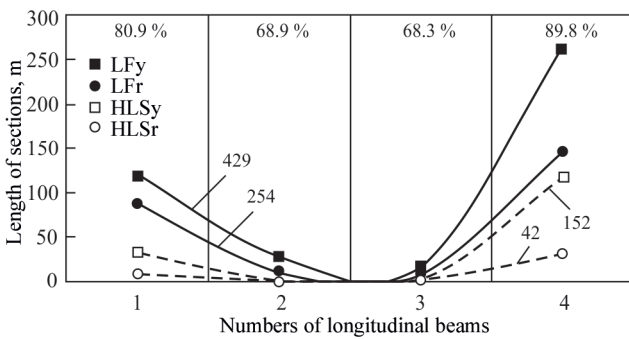
Figure 14. Total length of detected corrosion damages of the main longitudinal beams in the welding assemblies of the following elements: middle wall of the truss to the lower horizontal stiffener — HLS (y, r); lower wall to the lower flange of the truss — LF (y, r) (marks «y» and «r» characterize the depth of corrosion damages from 2.0 to 4.0 mm and more than 4.0 mm, respectively)

The smallest depth of corrosion damages was observed near the expansion joints in the trusses of the middle main beams No.2 and No.3, where debris was absent (Figure 14). In addition to the sections of the main beams No.2 and No.3, located near the expansion joints, other elements of these beams are in satisfactory condition.

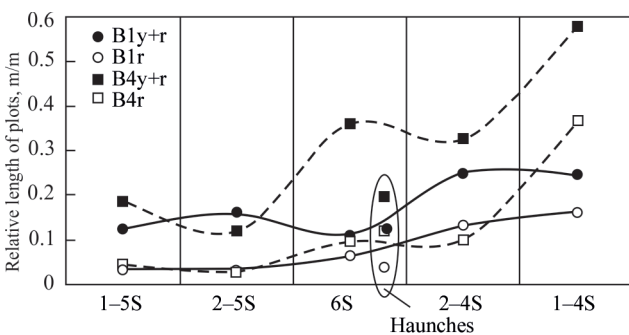
Figure 15. Relative length of detected sections damaged by corrosion in the welding-on assembly of the lower wall to the lower flange of the truss for the structures 1-5S; 2-5S; 6S; 2-4S; 1-4S of the end beams No.1 and No.4 to the controlled length of the structures (B1y+r is the total length of damages with a depth of more than 2.0 mm of the beam No.1; B1r is the total length of damages with a depth of more than 4.0 mm of the beam No.1; B4y+r is the total length of damages with a depth of more than 2.0 mm of the beam No.4; B4r is the total length of damages with a depth of more than 4.0 mm of the beam No.4)

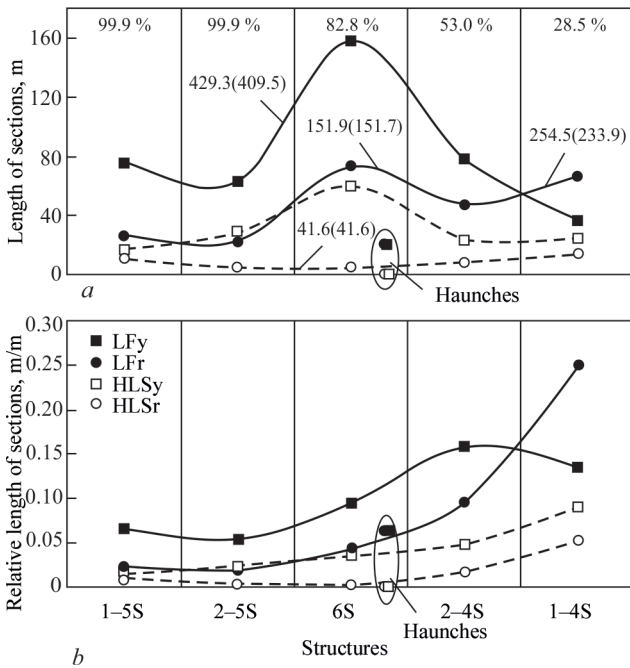
Thus, Figure 16, *a, b* shows a dependence of the detected corrosion-damaged areas of the inspected structures, where in the top of the diagram the percentage of the performed testing on the structures is indicated.

Figure 16. Length of detected sections damaged by corrosion of structures and percentage of performed testing (percentage of testing is indicated above) (a) and the relative length of detected sections damaged by corrosion of structures to the controlled length (b). The numbers indicate the total length, taking into account the data on haunches (in parentheses — without haunches) requires other approaches using probable methods. Thus, Figure 18 shows diagrams of distribution of detected damages to the trusses in the assemblies of welding-in the lower girth to the lower wall between the supports for the main beams No.1 and No.4. From the analysis of the results of this diagram it was found that the sections of detected damages are chaotic. The

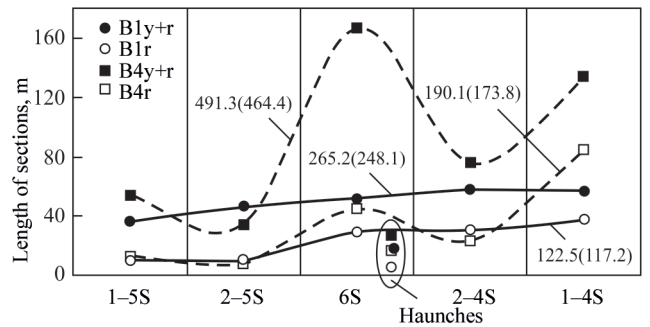
In this case, when evaluating the expected length of corrosion damages to the beams B1 and B2, a linear extrapolation between the found damaged sections and the controlled length was used. This approach provides only an approximate evaluation of possible damages, but can be useful when planning future repair works. A more accurate evaluation of damages

Figure 17. Example of predicting length of of detected sections damaged by corrosion in the welding-on assembly of the lower wall to the lower flange of the truss for the structures 1-5S; 2-5S; 6S; 2-4S; 1-4S of the end beams No.1 and No.4 (designation of curves as in Figure 15)

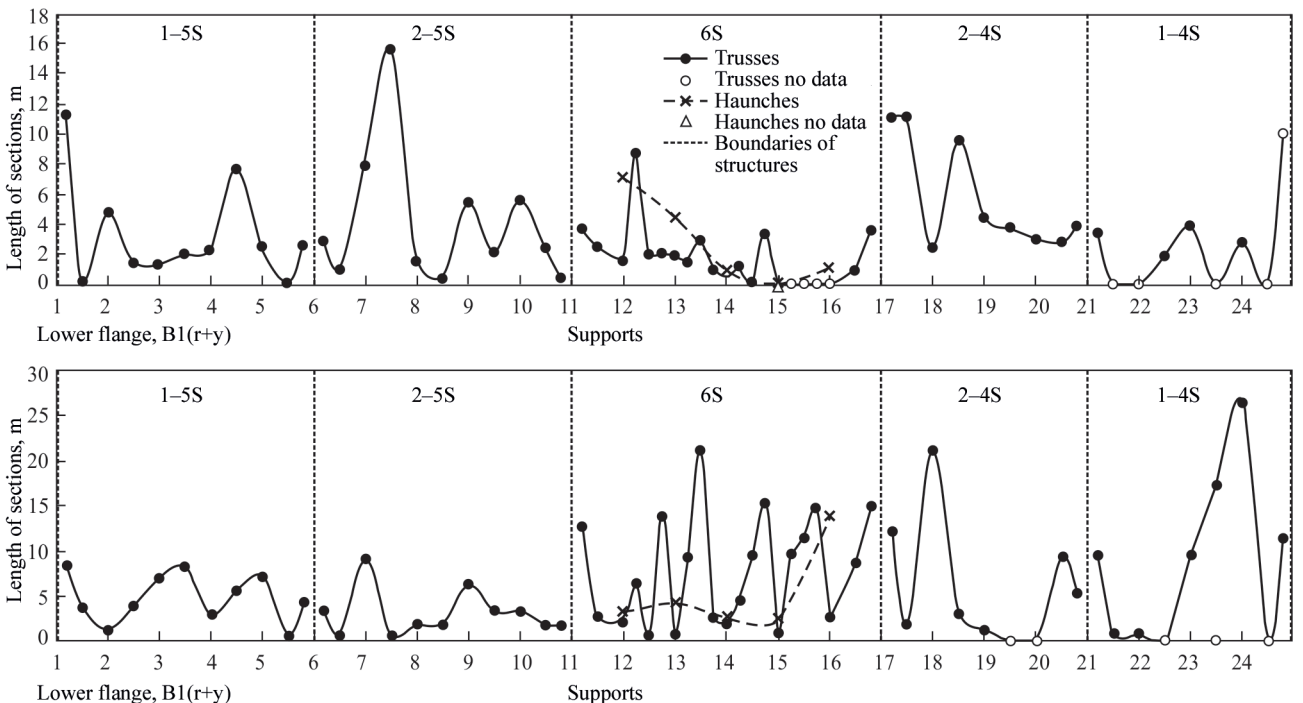
only similar pattern is an increase in damages along the boundaries of the structures.

Figure 18. Distribution of detected damaged sections in the welding zone of the lower girth to the truss wall between the supports for the main beams No.1 and No.2 (designation as in Figures 15, 17)
