EVALUATION OF DAMAGE OF ALL-WELDED LONGITUDINAL MAIN BEAMS OF THE E.O. PATON BRIDGE ACROSS THE DNIPRO RIVER

V.D. Poznyakov, V.P. Dyadin, Ye.O. Davydov and R.I. Dmytrienko

E.O. Paton Electric Welding Institute of the NAS of Ukraine

The problem of general evaluation of technical condition of main longitudinal beams of the E.O. Paton Bridge was considered based on the results of selective non-destructive testing of truss elements. It is shown that the main cause of damage to the elements of the main beams is corrosion of the nodal welded joints in the places of debris accumulation. High quality of welded butt joints made by automatic and semi-automatic submerged arc welding was noted. 10 Ref., 18 Figures.

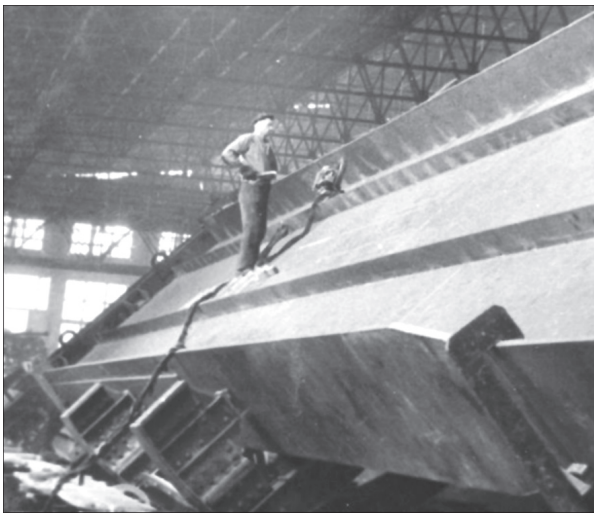
Figure 1. Welding of longitudinal stiffeners and girth welds of the truss [3]

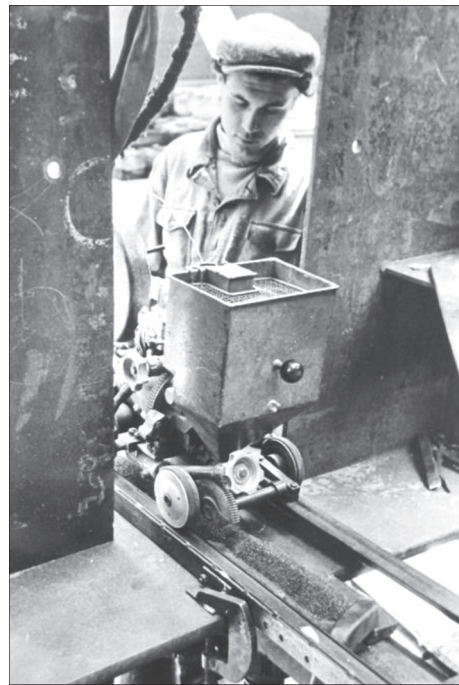
Figure 2. Example of applying automatic submerged arc welding of the lower girth while joining trusses of the main beams [4]

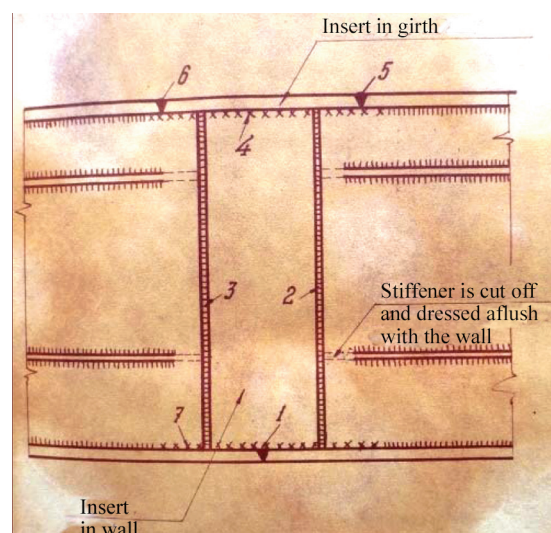
- assembly of erection joints to one-type butts of continuous trusses of double-T cross-section (Figure 3), which significantly simplified the assembly of trusses and reduced the time of welding works by using automatic and semi-automatic submerged arc welding;

- development of a special design of the erection joint of trusses with an insert in a vertical wall and an upper flange and a sequence of their joints by means of automatic submerged welding of girths with extension of a weld on additional laths (Figures 2, 3).

Figure 3. Order of erection assembly and welding of typical bridge trusses [4]

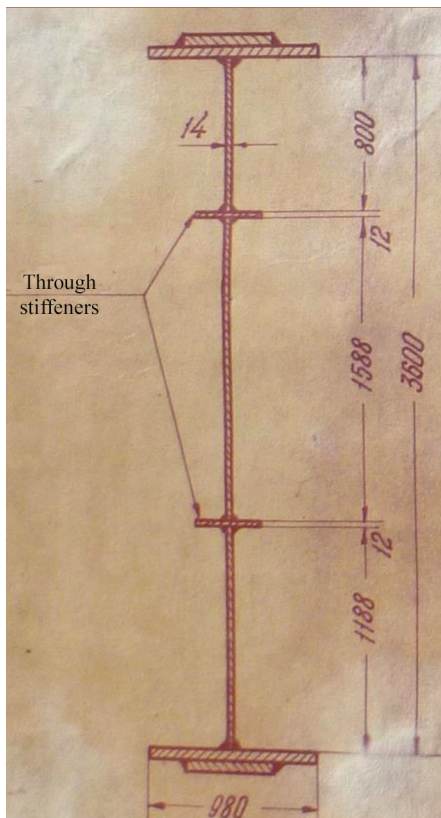
Figure 4. Cross-section of the truss of the main longitudinal beams of four- and five-span structures of the bridge [4]

to 80 mm, with a width of up to 1000 mm (Figure 4). The stability of the beam wall is additionally provided by vertical stiffeners mounted with a step of 7.25 m.

When designing horizontal stiffeners, their welding-on to the vertical wall of the truss without a full penetration was provided (Figure 4), which significantly reduced the residual stresses over the thickness of the metal and, as a result, considerably lowered the risk of propagating this defect.
